# Croydon South Walkability Assessment

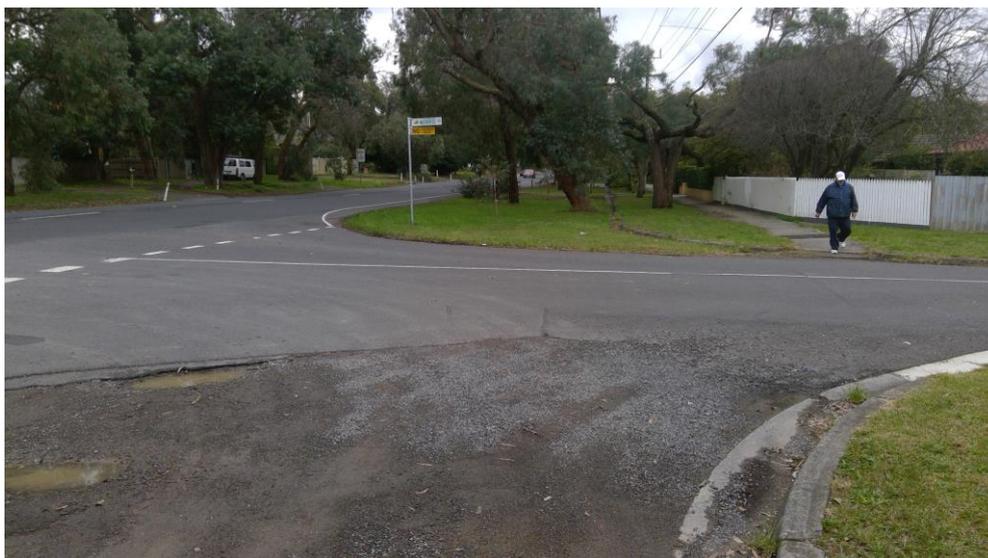
One of the most common issues identified in the assessment is the potential for high speed turning from main roads. Victoria Walks research [Safer Road Design for Older Pedestrians](#) identified right-turning and to a lesser extent left-turning vehicles (usually failing to give way) as the most common crash scenarios. This is a particular concern on Bayswater Rd, where many of the intersections have a splayed configuration that would allow fast turning. The footpath also tends to be some distance from the roadway. While theoretically this allows drivers to move off the main road before giving way, this may not be realistic, and also means pedestrians crossing side streets will be less conspicuous to vehicles on Bayswater Rd.

*Figure 4 – common intersection configuration on Bayswater Rd*

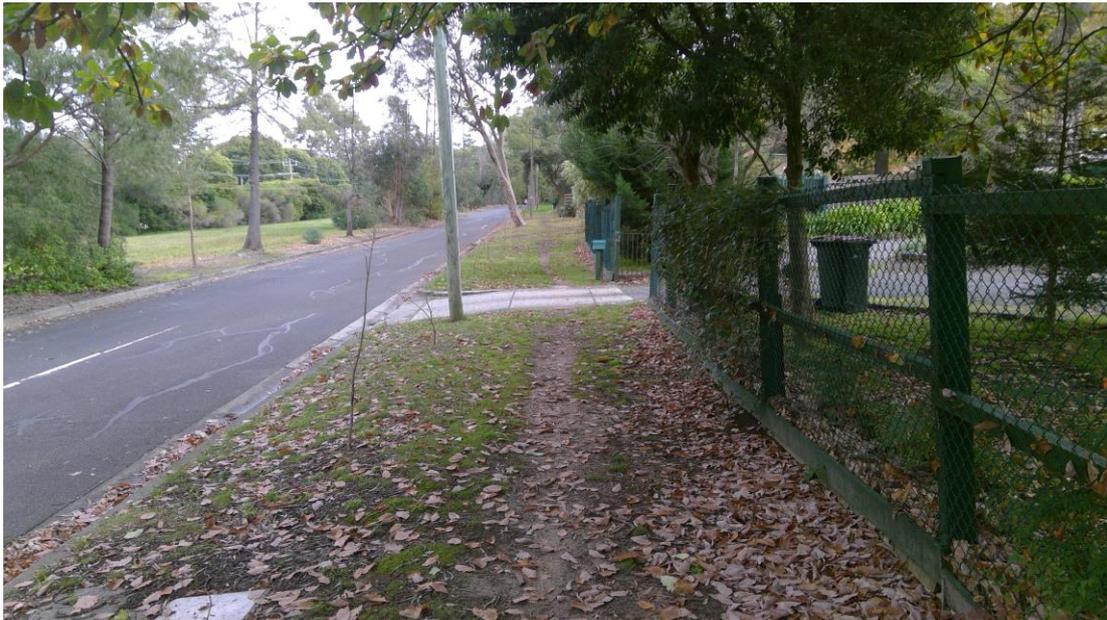
*Figure 5 – a number of streets in Croydon South have no footpath, or only on one side*

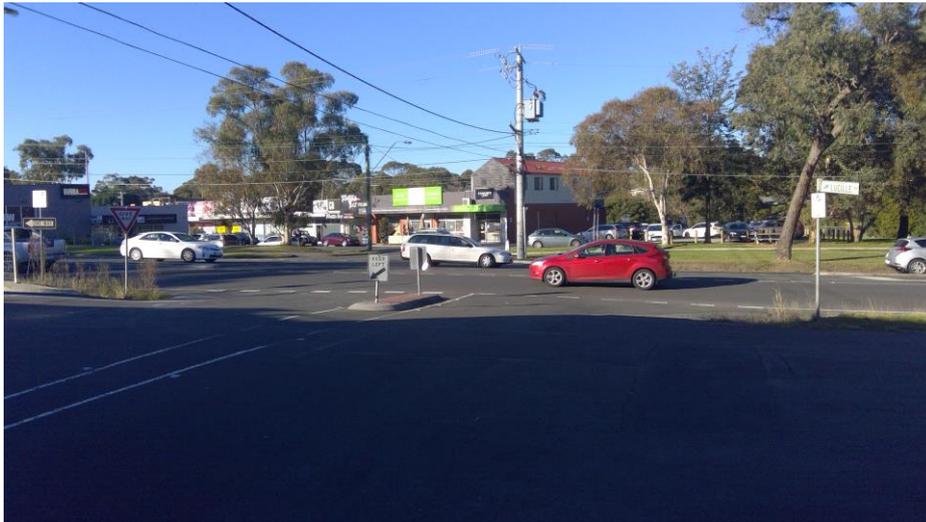
While there is provision to cross at the signalised intersection, it is not realistic to expect people to do that, given that it would involve walking a total additional distance of about 300 metres (there and back).

*Figure 6 – the current situation facing people wanting to cross Bayswater Rd in the centre (Lucille Ave)*

We have made a number of recommendations in Section 5 to improve pedestrian connection, safety and amenity in the centre. The most important of these is provision of a pedestrian crossing of Bayswater Rd at Lucille Ave. This crossing would serve three key purposes:

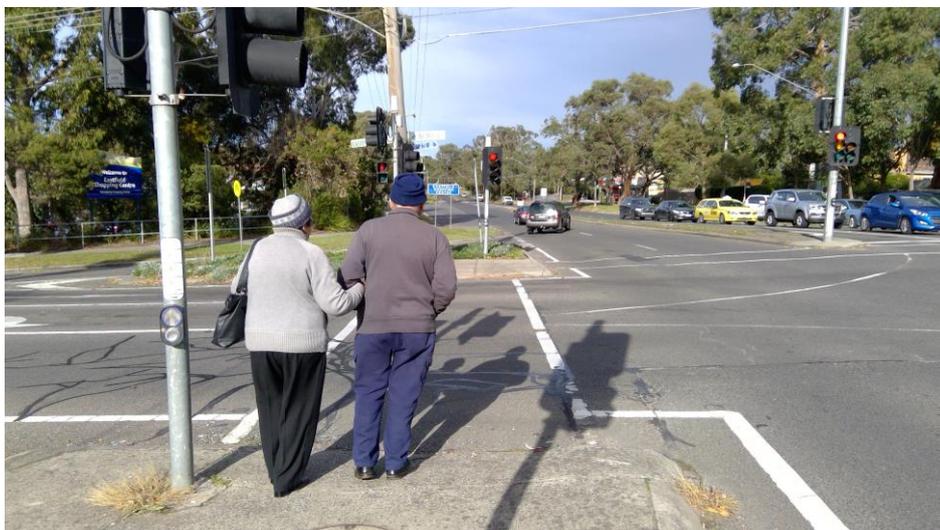
Despite the presence of zebra crossings, the slip lanes at the intersection of Bayswater and Eastfield Roads are a concern. In our view, drivers tend to be focused on other traffic when approaching slip lanes. Victoria Walks is aware of pedestrians who have been killed on zebra crossings over slip lanes in Melbourne. We have recommended a number of changes at this intersection including construction of raised platforms for the zebra crossings to force drivers to slow and further highlight the need to give way.

*Figure 7 – crossing at the intersection of Eastfield and Bayswater Roads*

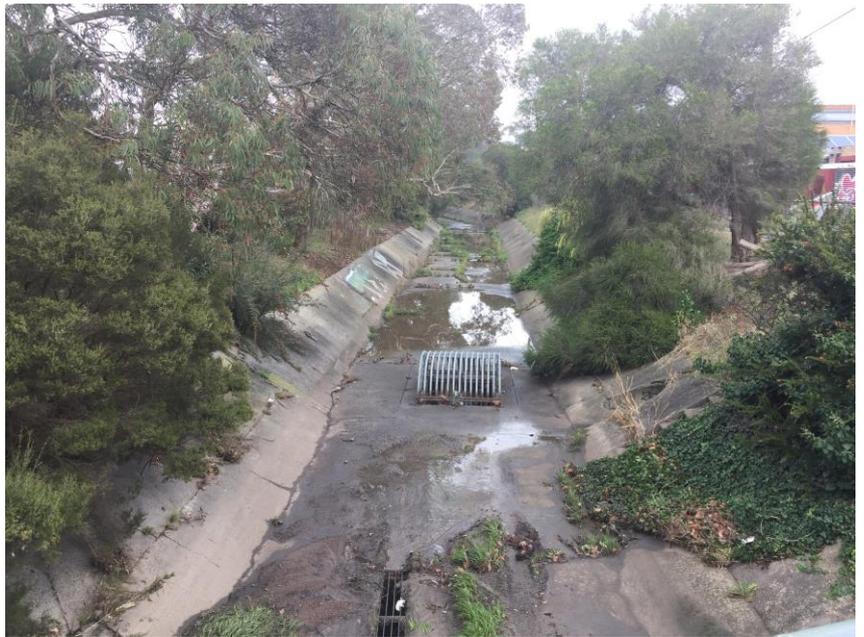
Tarralla Creek would seem to be a missed opportunity to provide a positive interface and approach to the centre. We have recommended that the council explore opportunities to naturalise the stream channel (point 3 in Section 5). This would be particularly important at the southern end of the centre, where the stream is a prominent feature of the approach but the concrete drainage channel and fencing does not present well. Subject to meeting drainage requirements, there may be an opportunity to turn a negative into a positive and make this an attractive landscape feature. It may also be possible to expand the centre somewhat and provide café's with outdoor dining overlooking this area.

Figure 8 – Tarralla Creek next to the centre. Not the aesthetic asset that it could be

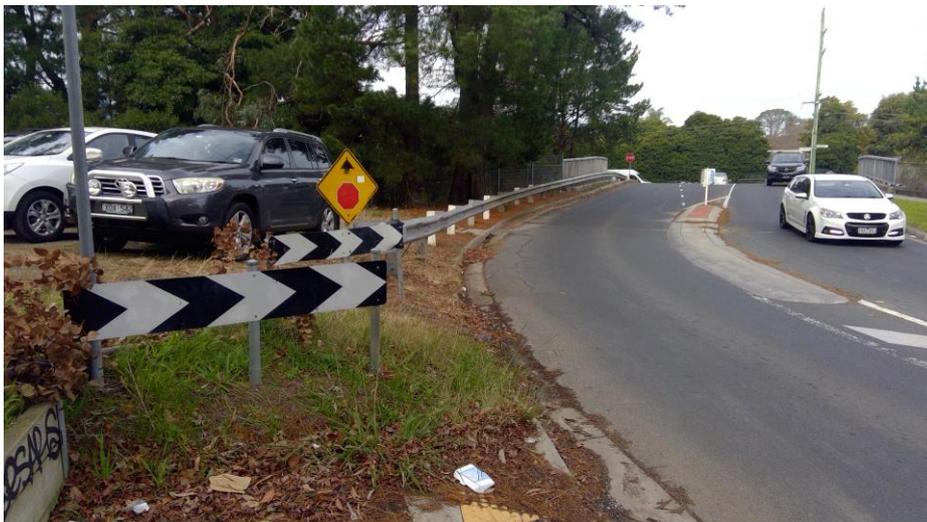
Figure 9 – on the return route from Maroondah Hospital, the footpath on the north side of Eastfield Rd ends at a critical point, the crossing of the railway line.

Eastfield Rd in this area is only one lane in each direction but is wide and traffic feels fast (60 km/h limit). The absence of a footpath along much of the northern side of Eastfield Rd is a significant issue given that it is not easy to cross. Council has some intention to address this, but Victoria Walks do not have detail plans and so have provided our own specific recommendations.

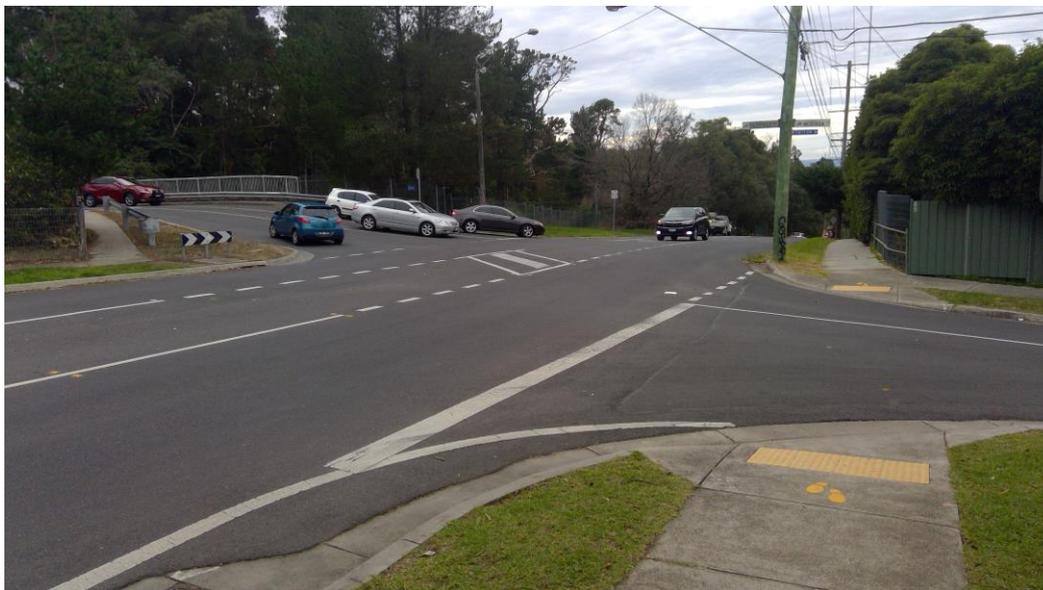
There are no pedestrian crossings of Eastfield Rd, apart from the intersection of Bayswater Rd. The intersection with Railway Ave is a particular concern, with fast moving and turning traffic and no crossing facilities. Discussions with people in this area suggest they often avoid crossing here because it is (probably correctly) perceived as dangerous.

*Figure 10 – the intersection of Eastfield Rd (top, all the cars in this photo are on Eastfield Rd), Morinda St (right) and Railway Ave (left).*

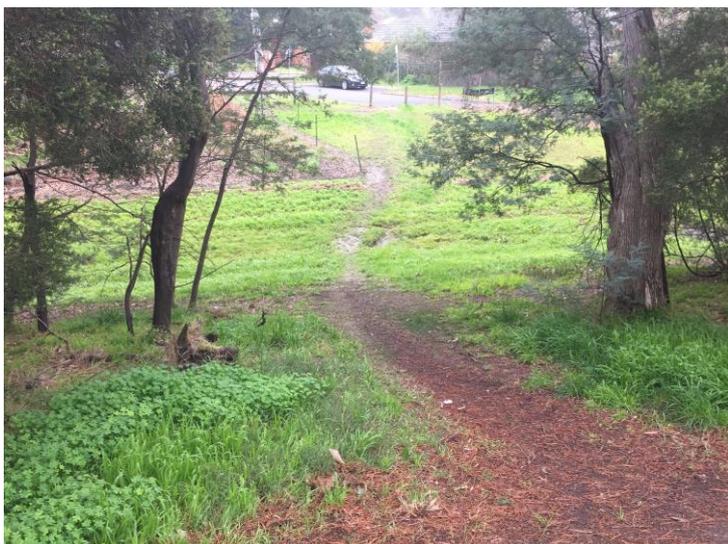
Figure 14 – informal connection only between Morris Rd and Tarralla Creek Trail

Point 5. No connection to Morris Rd	Tarralla Creek Trail	No path connection to Morris Rd, bur clear desire line.	Construct a path connection.	M	Open space?
