# Croydon South Walkability Assessment

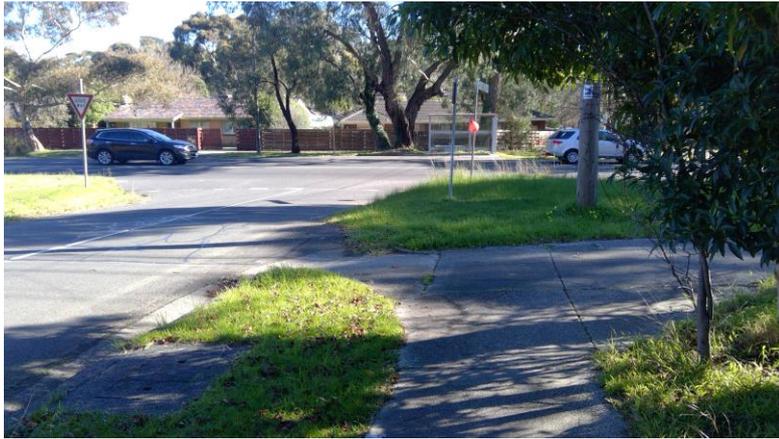
Bayswater Rd is a bus route, but pedestrian connections to the bus stops and capacity to cross this busy road to access the stops or other destinations is often limited. Many of our recommendations seek to address this.

Maroondah City Council is advocating to VicRoads for improvements that will include curb and channel, footpaths and pedestrian crossings.

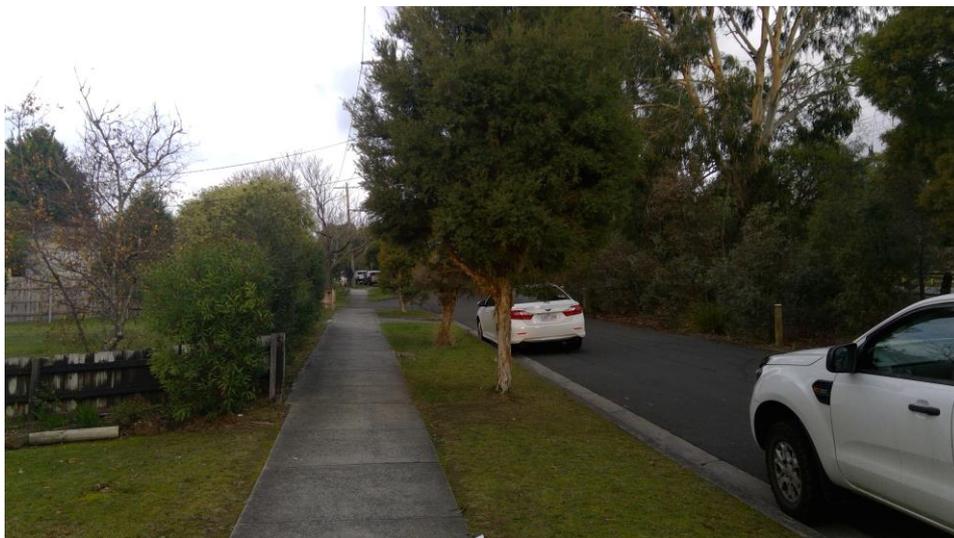
Figure 12 – typical north side of Eastfield Rd between Tarralla Creek Trail and park access at Blazey Rd

The south side of Eastfield Rd is more conventional, with only a narrow nature strip approximately 1.5 metres wide separating the footpath from the road and a range of side streets to cross. These side streets

are generally configured with a standard design at a right-angle to Eastfield Rd, so the potential for fast turning into them is not unduly high. For that reason, we have identified desirable treatments without allocating them a high priority. Nonetheless, Eastfield Rd is fairly narrow for a major road, with no capacity for vehicles to wait to turn right without holding up the traffic behind. This may make drivers distracted and impatient to turn and therefore less likely to identify and give way to a pedestrian crossing a side road.

There is no pedestrian crossing of Eastfield Rd in the area, apart from the intersection of Bayswater Rd. We have recommended that a crossing be provided to connect directly into the footpath along The Mall at the centre. This is a critical need, because it would serve anyone wanting to walk to the centre from the north-east of the catchment, including the north side of Eastfield Rd and the Tarralla Creek Trail. People coming from the north along Bayswater Rd might also chose to use this crossing rather than the signalised intersection.

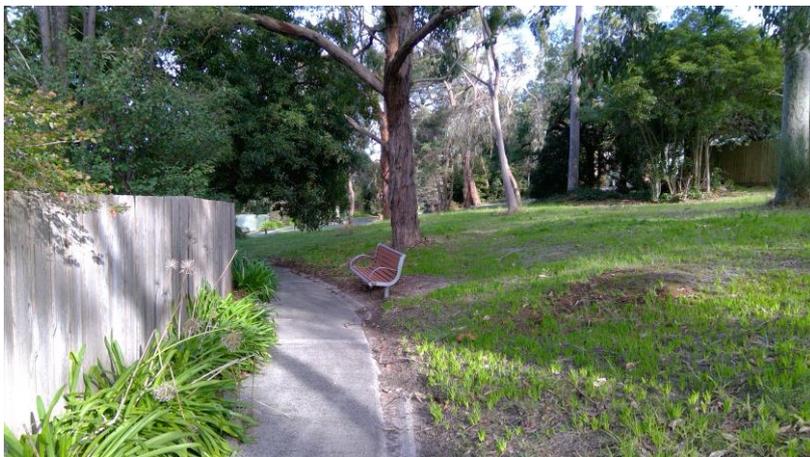
*Figure 15 - The connection between Eastfield Rd and Orchard Drive. There are a number of excellent pedestrian connections through open space that could be promoted*

Residents living within easy walking distance of the centre may not necessarily be conscious of that fact. This may be particularly true of people for whom the shortest route is via shortcuts through open space rather than the street network alone. Examples would be residents around Lusher Rd, Jesmond Rd, Shane Cres and Orchard Drive.
